**MISHAPS WITH OXYGEN IN NASA OPERATIONS**

by Paul M. Ordin  
Lewis Research Center  
Cleveland, Ohio

**TECHNICAL PAPER** proposed for presentation at  
Oxygen Compressors and Pumps Symposium  
sponsored by the Compressed Gas Association  
Atlanta, Georgia, November 9-11, 1971

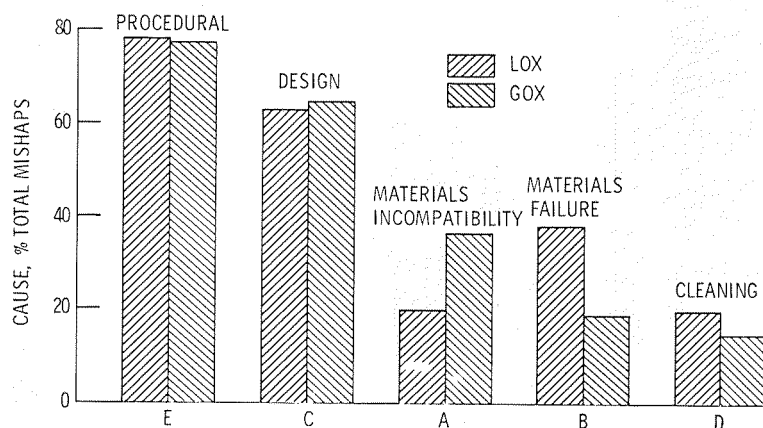
Figure 3. - Comparison of cause factors for liquid and gaseous oxygen.

Figure 3 shows the comparison of the number of mishap causes for the liquid and gaseous oxygen. Note the substantial increase in gaseous oxygen mishaps due to material incompatibility. With respect to possible reactions between the materials and oxygen, we should expect a greater number of mishaps with gaseous oxygen since a small volume of gas is generally a prerequisite to the ignition of the material. The thermal mechanism of ignition assumes hot spots could not occur without the presence of the gaseous phase at the spot. The large heat sink provided by LOX contact precludes hot spots on immersed materials unless the heat source is strong and is abetted by concurrent chemical reactions between LOX and the material being heated. The liquid, therefore, would have a reduced effect on initiating any reaction of the materials with oxygen until sufficient heat was transferred to form the gaseous state. Adiabatic compression as a means of producing high temperature for ignition of the materials also becomes inefficient at cryogenic temperatures. The theoretical temperature due to adiabatic compression can be calculated from the values of final and initial pressure and the ratio of specific heats (1.4 for oxygen). A pressure ratio of about 47,

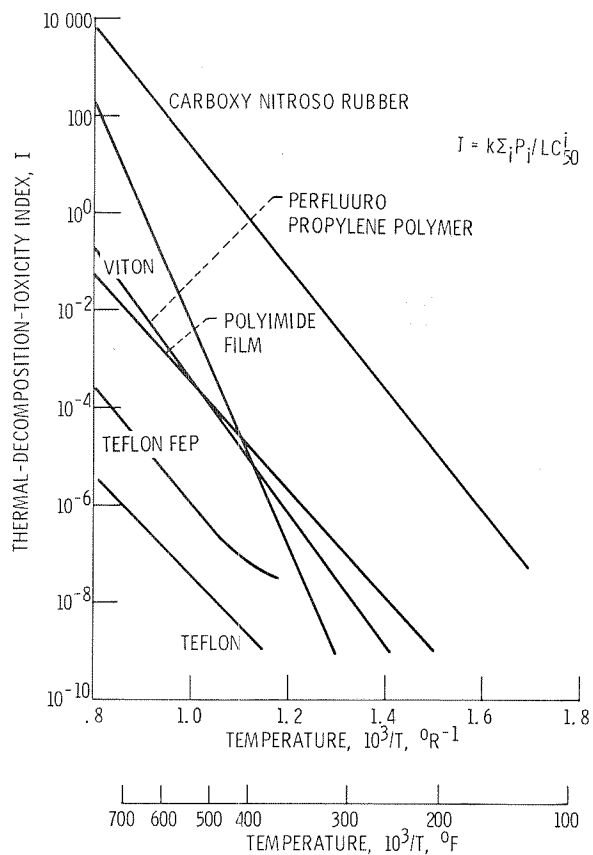
Figure 4. - Thermal-decomposition-toxicity index versus temperature.

recommended materials, when tested in oxygen-rich environments, may be non-igniting or self-extinguishing or slow burning, but the decomposition products may be toxic and present hazards to personnel. Toxic gases and vapors given off include carbonyl fluoride ( $\text{COF}_2$ ), carbon monoxide ( $\text{CO}$ ), formaldehyde ( $\text{H}_2\text{CO}$ ), phosgene ( $\text{F}_2\text{CO}$ ), hydrogen fluoride ( $\text{HF}$ ), chloroform ( $\text{HCCl}_3$ ), hydrogen cyanide ( $\text{HCN}$ ) and carbonyl chloride ( $\text{Cl}_2\text{CO}$ ). Results of thermal-decomposition toxicity evaluations as a function of temperature for many of the polymeric materials have been compiled by the Aerospace Corporation and are shown in Figure 4 (ref. 6).

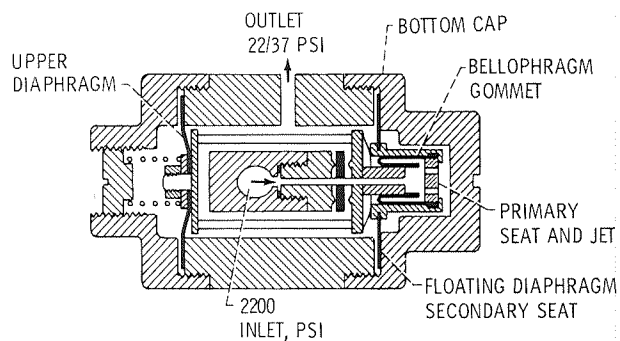
Figure 5. - Cutaway sketch of the resuscitator regulator illustrating the functioning position of various components

equipment for launch facility operations. The probable source of the fire was the regulator primary seat made of nylon. Ignition was most likely promoted by small metal particles which were found in the system. A schematic diagram of the resuscitator regulator is shown in Figure 5 and a photograph of the ruptured safety valve in Figure 6. A view into the regulator body illustrating the burned portions is shown in Figure 7.

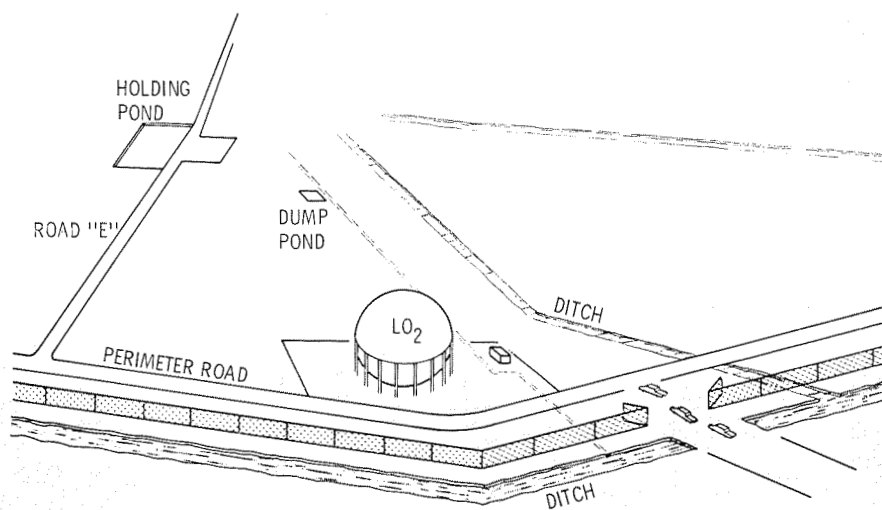
Figure 8. - Storage and drainage ditch area.

During launch pad clearing operations, three security cars were driven into an oxygen enriched area, the guards parked their cars, shut the engines, and got out for an inspection of the area. The LOX which was being dumped as part of normal operations vaporized and created an oxygen cloud which drifted into the path of the cars causing severe fire damage to the three vehicles. Prior to and during LOX pump operations for loading the Apollo Saturn vehicle, the LOX used in the storage area piping chilldown is normally drained into a ditch beyond a perimeter fence. Location of the LOX storage tank, three parked cars and drainage ditch is shown schematically in Figure 8. The drainage ditch approximately 40 ft. wide and 5 ft. deep is located about 227 ft. from the liquid oxygen storage tank.

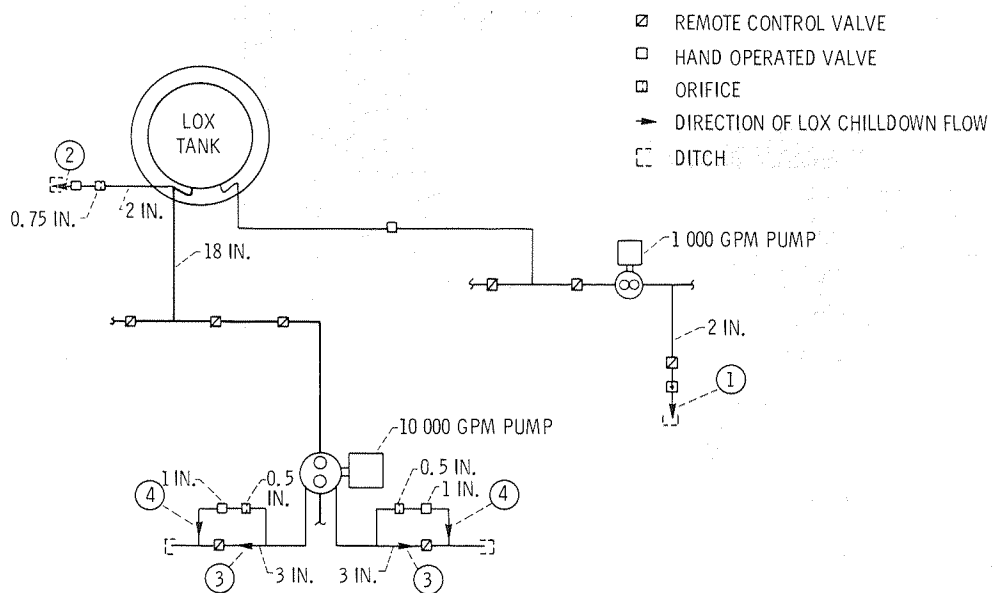
Figure 9. - LOX system schematic showing LOX chilldown outlets to ditch.

A schematic showing the LOX chilldown outlets to the ditch is shown in Figure 9. Outlet number 1 used to chilldown the 1000 gpm pump was opened for 40 minutes and dumped 8000 gallons into the ditch. Outlet number 2 used to chilldown the 18" tee at the suction inlet of the 10,000 gpm, dumped a total flow of 2250 gals. Outlet number 3, used to chilldown the 10,000 gpm, and outlet number 4, opened after the three minute drain of outlet 3, passed a total of 860 gallons into the drainage ditch. The quantity of LOX dumped into the ditch was about

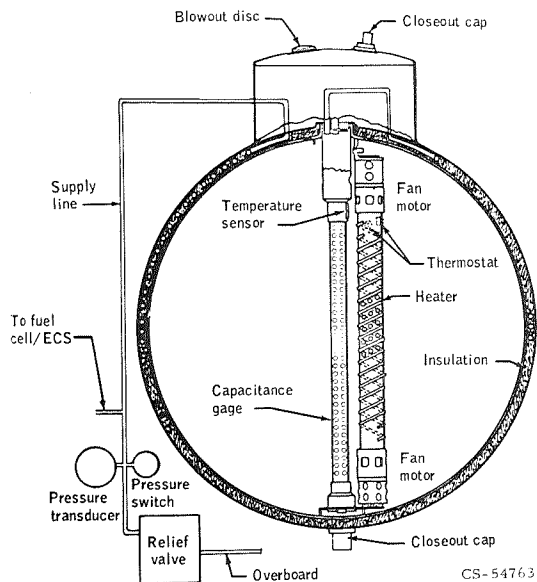
Figure 16. - Oxygen tank no. 2 internal components.

The oxygen and hydrogen tanks and fuel cells are located within the service module of the spacecraft. The arrangements of the equipment are shown in Figure 15. The internal components in the oxygen tank are shown in Figure 16. Two heaters in each tank supply the heat necessary to maintain the design pressure in the oxygen tank. Fans circulate the oxygen over the heating elements to reduce any stratification present in the supercritical oxygen.

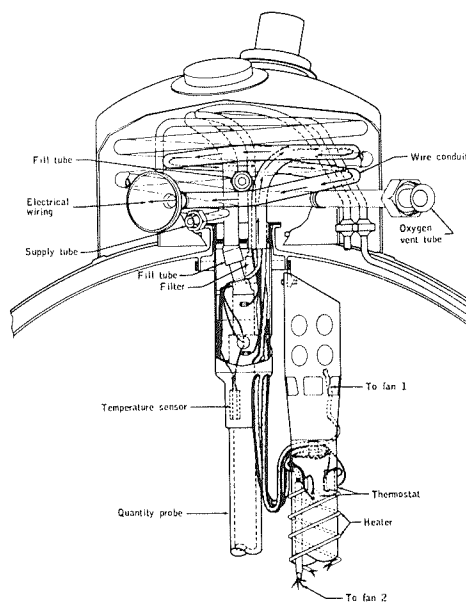
Figure 17. - Oxygen tank wiring and lines.

The wiring conduit which contained the power leads for the fan motors and heaters and the instrument leads are fed through the vacuum shell in a hermetic seal which are then passed into the oxygen vessel through about 1/2 inch diameter tubing. Figures 17 and 18 show the oxygen tank wiring and lines. The 1/2 inch diameter tubing containing the wiring was formed into a 10 inch coil with about 3 turns. The interior of the conduit is open to the pressurized oxygen to the point of the hermetic seals.

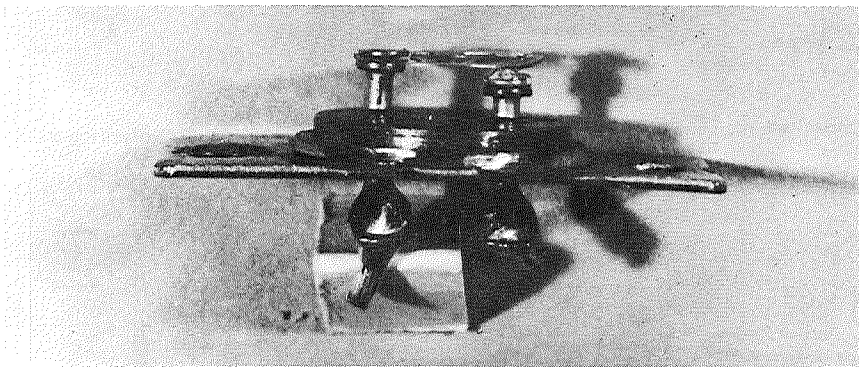
CS-54827

were connected in series with each of the heating elements to avoid excessive temperatures. The heater circuit would be automatically opened when the internal heater tube wall temperature reached 90°F and closed at 70°F. The use of the heaters to assist in detanking required a manual mode of operation which resulted in the switches opening under a load at twice the normal operating conditions for each heater. Tests showed that opening the switches under these conditions would fuse the contacts closed at the instant of power interruption. Tests have verified that with the heater on, for the duration experienced during prelaunch operations, fan motor wire insulation would be severely degraded. A photograph of the fan motor wire damage from simulated heater tests is shown in Figure 20. A fused thermal switch control obtained under simulated tests is shown in Figure 21.

Figure 21. - Fused thermal switch control.
